**MILLER CREEK:
Pioneering compound channel still provides habitat
while conveying flows in stabilized channel**

MARIN COUNTY, CALIFORNIA

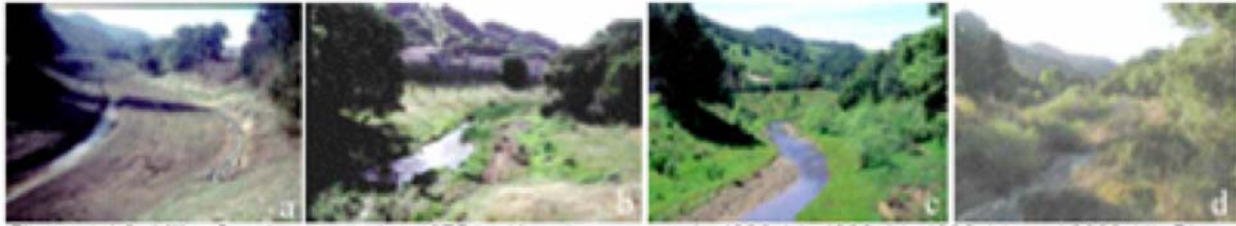
Photo credits (a) – (c) by Jeffrey Haltiner and photo (d) by Wan-Chih Yin and Caitlin Pope-Daum.
