## ***East Prong of the Roaring River, Stone Mountain State Park, NC***

### **What was done and why?**

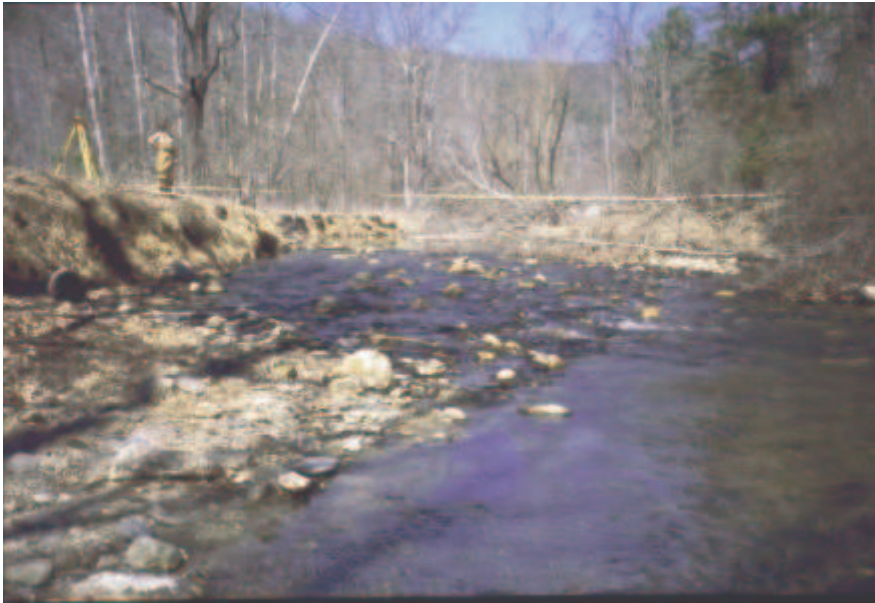
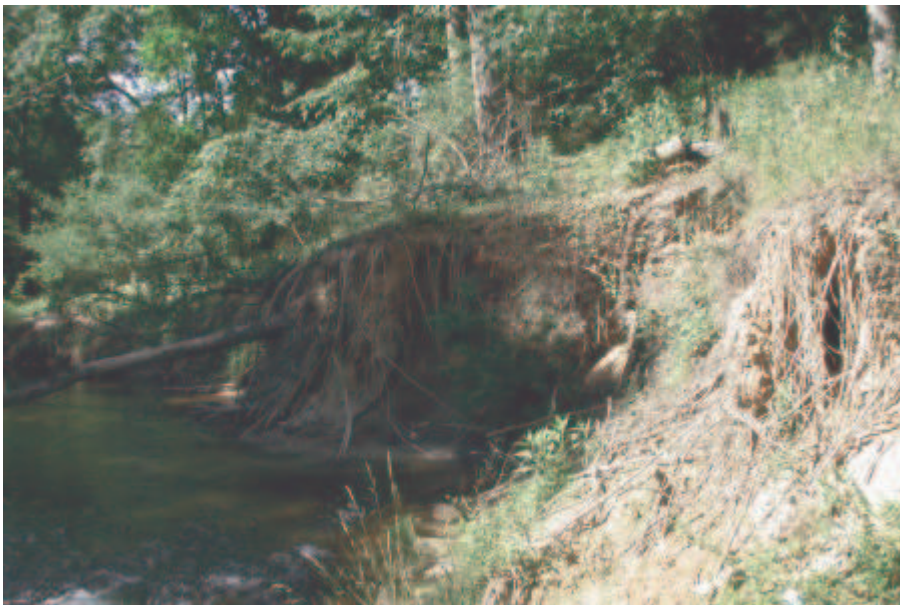
pre-restoration (photos courtesy of NC Stream Restoration Institute)

To restore the East Prong, a complete floodplain rehabilitation project was undertaken. This project included stabilizing stream banks and installing in-stream structures such as cross-vanes, rock vanes, and j-hook vanes to restore proper channel dimensions. Six thousand feet of new channel were excavated with the old, unstable reaches either filled or left as ponds to provide habitat for birds, amphibians, and other wildlife. The restoration of the channel to its original floodplain has resulted in the restoration and enhancement of wetlands that will filter runoff and provide wildlife habitat. Finally, riparian vegetation was planted using native species. When complete, the stream length will have increased from 8,336 feet to 10,662 feet. The additional stream length and the riparian vegetation will greatly increase the habitat and recreational functions of the East Prong River.

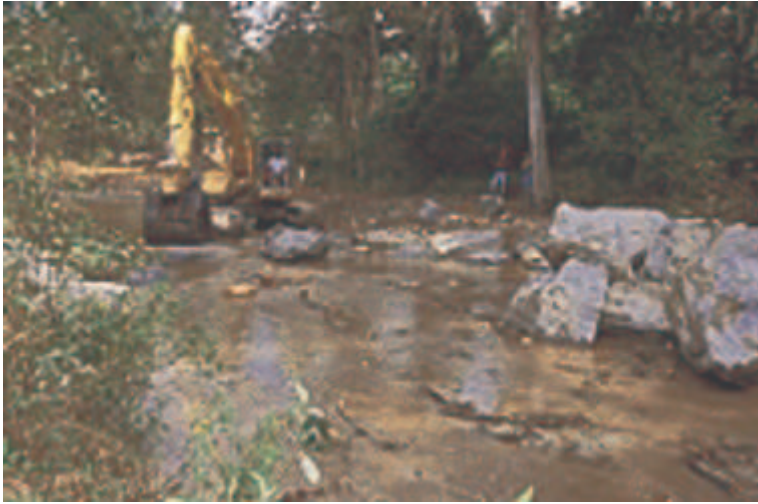
Under construction (photo courtesy of NCSU College of Agricultural and Life Sciences)

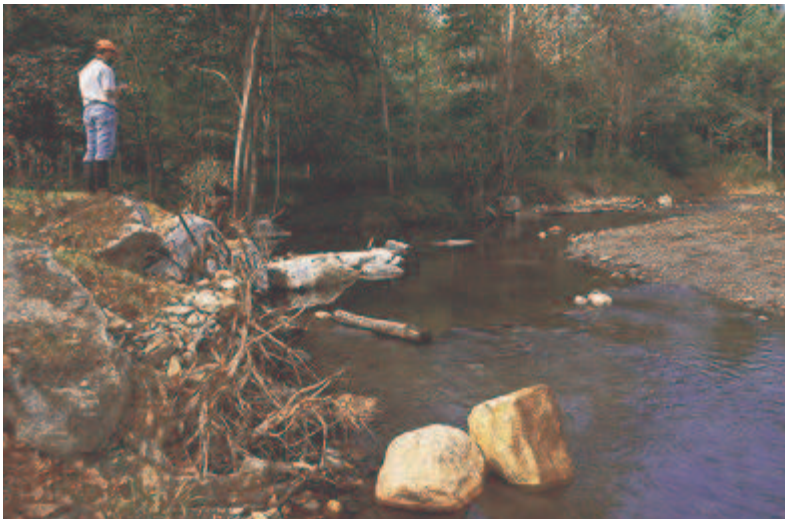
post-restoration (photo courtesy of NCSU College of Agricultural and Life Sciences)
